### **3.0 PHOTO ENFORCEMENT EQUIPMENT INSTALLATIONS**

## **San Diego Photo Enforcement System Review**

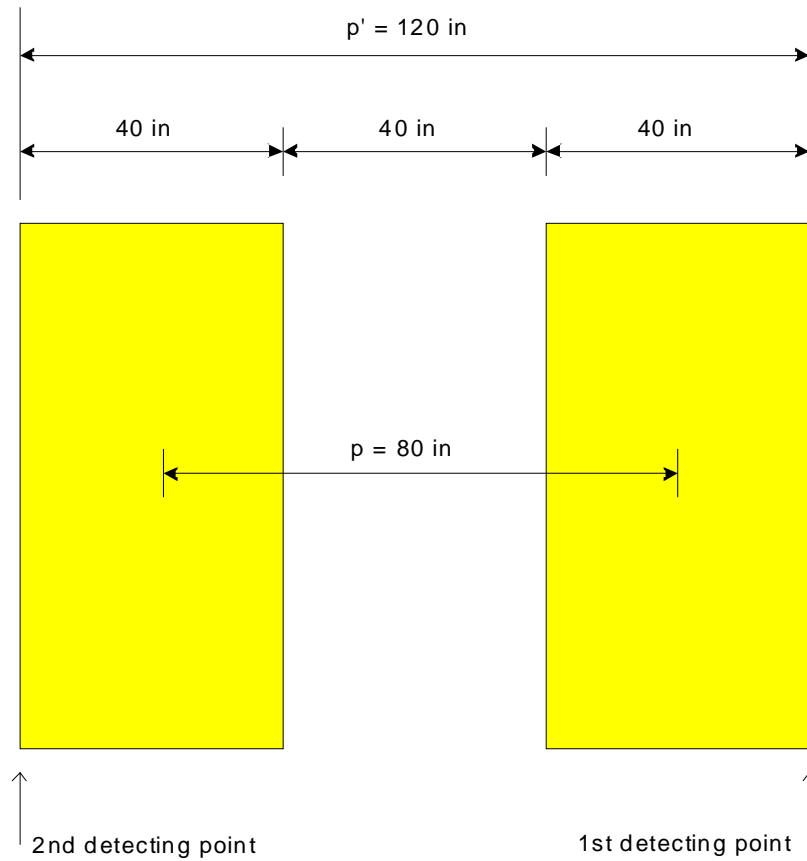
**Figure 3-1  
LONG PITCH LENGTH ERROR**

Figure 3-1 illustrates a possible error condition where a vehicle is detected on the leading edge of the first loop and on the trailing edge of the second loop.. In Note that this error condition is possible but is not likely as evaluated this instance, the vehicle actually travels a distance of 120 inches, from the first loop to the second loop, but the camera unit calculates the vehicle speed based on a pitch measurement of 80 inches. This error results in the vehicle speed being underestimated.

$$t_{est} = \frac{p'}{p} \times t_{true} \quad (1)$$

$$v_{est} = \frac{p}{t_{est}} = \frac{p}{\frac{p'}{p} t_{true}} = \frac{p}{p'} \times v_{true} \quad (2)$$

Since  $p$  is 80 inches and  $p'$  is 120 inches under the typical loop alignment conditions, equation 2 can be rewritten as follows:

$$v_{est} = 0.67 \times v_{true} \quad (3)$$

Equation 3 indicates that the estimated speed will underestimate the true speed by 33 percent. For vehicles where the speed is incorrectly calculated at less than the minimum speed

threshold, the camera will not be triggered and no violation will be recorded. For vehicles where the speed is calculated at more than the minimum speed threshold, the estimated time that the vehicle entered the intersection will be miscalculated as earlier than the actual time. Both of these errors result in motorists who ran a red light not being photographed or, in other words, the possible error condition is in the motorists' favor and cannot result in motorists being improperly cited.

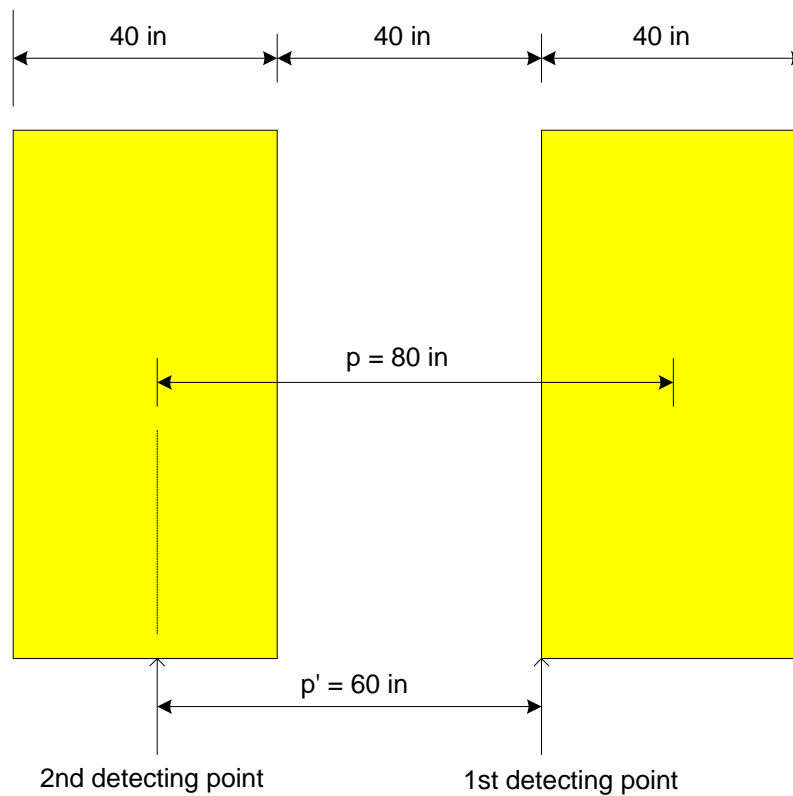
**Figure 3-2**  
**SHORT PITCH LENGTH ERROR**

Figure 3-2 illustrates a possible error condition where a vehicle is detected on the trailing edge of the first loop and at the center of the second loop. In this instance, the vehicle actually travels a distance of 60 inches, from the first loop to the second loop, but the camera unit calculates the vehicle speed based on a pitch measurement of 80 inches. This error results in the vehicle speed being overestimated.

Since  $p$  is 80 inches and  $p'$  is 60 inches, equation 2 can be rewritten as follows:

$$v_{est} = 1.33 \times v_{true} \quad (4)$$

Equation 4 indicates that the estimated speed will be higher the true speed by 33 percent. For vehicles where the speed is incorrectly calculated at more than the minimum speed threshold, the camera will be triggered and a violation will be recorded. For all vehicle photographed, the estimated time that the vehicle entered the intersection will be miscalculated as later than the actual time.

In the worst case of a vehicle actually traveling at 11.6 miles per hour (estimated speed calculated to be 15 miles per hour), the estimated time that the vehicle entered the intersection will be calculated in error by approximately 0.14 seconds. For a vehicle actually traveling at 30 miles per hour, the magnitude of the error would be approximately 0.06 seconds. The magnitude of this error is less than that the length of the minimum grace periods being used and, consequently, would not result in motorists being improperly cited.

It is possible that a vehicle could be detected on the trailing edge of the first loop and at the leading edge of the second loop, meaning that the vehicle has only traversed a distance of 40 inches and that the vehicle speed would be overestimated by 100 percent. With errors of this magnitude, it is possible that motorists could be improperly cited. However, given that the vehicle detection loops are configured the same, this possible error condition is considered to be extreme and not applicable for this analysis.

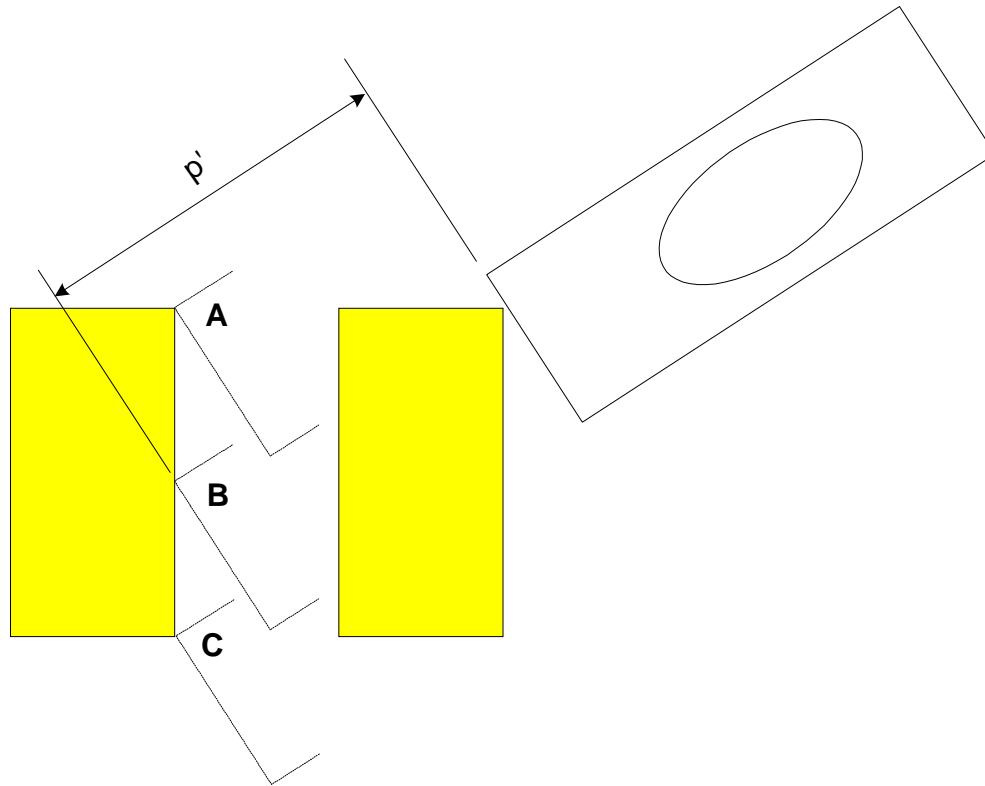
**Figure 3-3**  
**EXAMPLES OF POSSIBLE COSINE ERRORS**

Errors referred to as cosine errors may occur when a vehicle passes the loops with an angle against the loop alignment axis as illustrated in Figure 3-3.

The actual pitch length ( $p'$ ) depends on the detecting point of the second loop (points A, B, or C in Figure 3-3). The minimum pitch length ( $p'$ ) occurs when the vehicle meets the second loop at point A while the maximum pitch length ( $p''$ ) occurs when the vehicle is detected at point C of the second loop as illustrated in Figure 3-3.

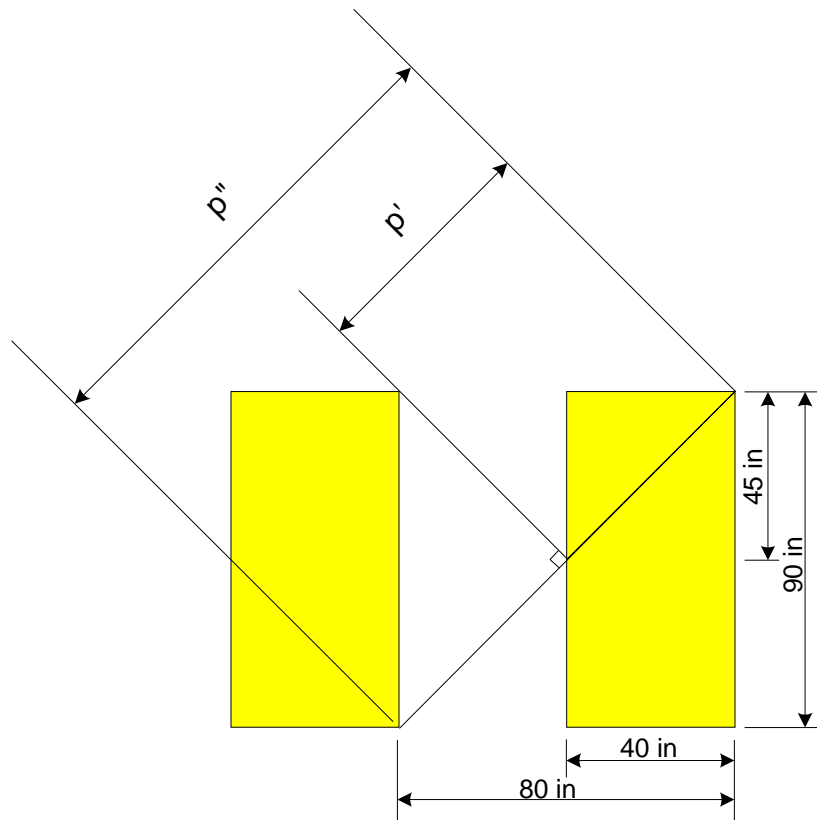
**Figure 3-4**  
**MINIMUM AND MAXIMUM PITCH LENGTHS OF COSINE ERROR**

$p'$  and  $p''$  can be computed from the geometric configuration as shown on Figure 3-4:

$$p' = \sqrt{40^2 + 45^2} = 60.2 \quad (5)$$

$$p'' = \sqrt{80^2 + 90^2} = 120.4 \quad (6)$$

From Equations 2, 5, and 6, the relationships between the true speed and the estimated speeds can be obtained as follows:

$$v'_{est} = \frac{p}{p'} \times v_{true} = 1.33v_{true} \quad (7)$$

$$v''_{est} = \frac{p}{p''} \times v_{true} = 0.67v_{true} \quad (8)$$

When the speed is estimated with the minimum pitch length  $p'$ , it is overestimated by 33 percent due to the underestimated travel time between the loops. Where the speed is incorrectly calculated at more than the minimum speed threshold, the camera will be triggered and a violation will be recorded although the vehicles actual speed was less than the threshold.

When the vehicle speed is estimated with the maximum pitch length, it will be underestimated by 34 percent due to the overestimated travel time between the loops. In this case, motorists who might be cited based on their actual vehicle speeds will not be photographed. The error is in the motorists' favor and motorists will not be improperly cited.
